Plans

The 60 closed and semi-closed spaces, three courtyards and a multitude of passages and staircases of the mud-brick house were all in derelict state. After removing debris, shoring structures, rebuilding ceilings and protecting the roofs, the building was surveyed and examined for 'incorrect' interventions. Mechanical and electrical systems were introduced where none had existed, with channels beneath the courtyard feeding risers and ducts throughout the house. The south-west wing of the upper floor provides office space for the Manouchehri Foundation and Institute for Historic Cities, a local NGO that aims to protect, preserve and promote historic places, giving them contemporary relevance. The restored house also contains space for large gatherings and guest rooms for visiting academics.

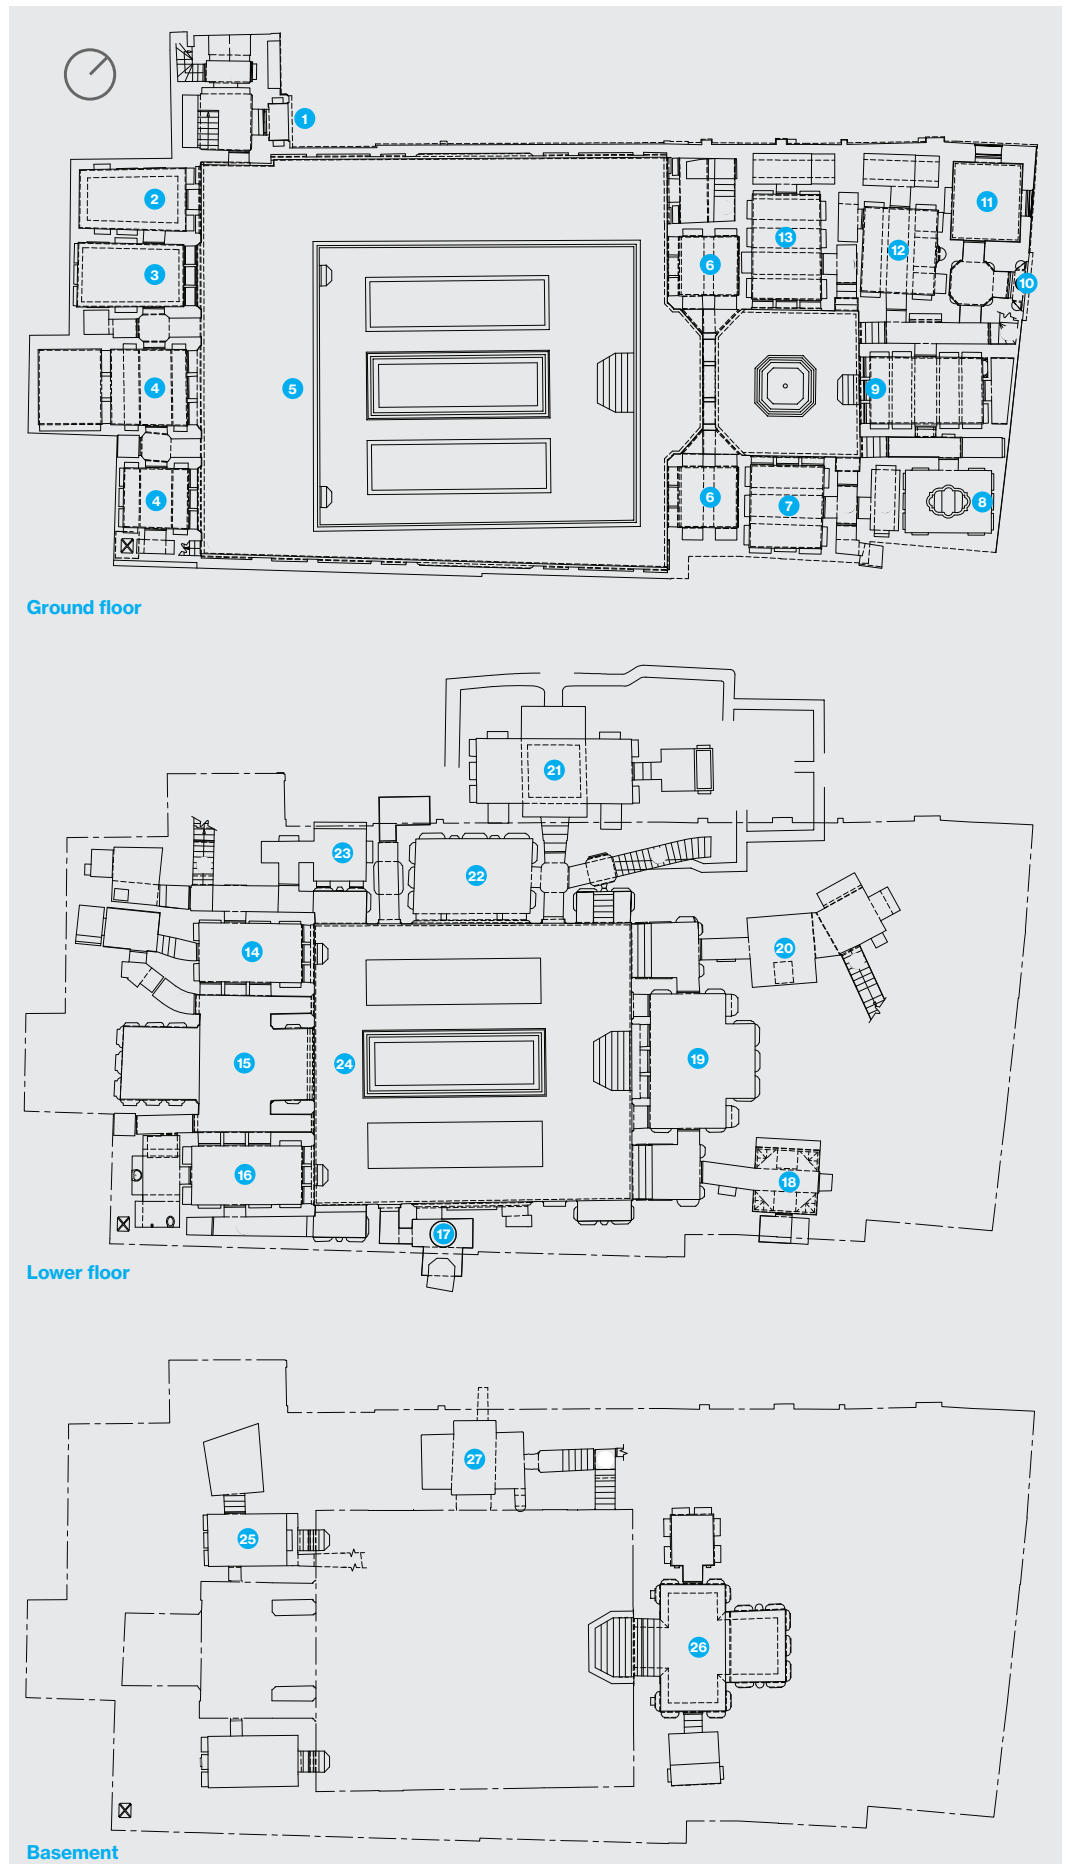
- 1 West entrance and foyer
- 2 Reception room
- 3 Meeting room
- 4 Office
- 5 Upper Courtyard
- 6 Upper Courtyard veranda
- 7 Yellow room
- 8 Hammam
- 9 Dining room and north-east court
- 10 North entrance
- 11 Washroom
- 12 Green room
- 13 Pink room
- 14 Amber room
- 15 Pool veranda
- 16 Blue room
- 17 Water well and basin
- 18 Clay bedroom
- 19 Living room
- 20 Kitchen
- 21 Multimedia room
- 22 Garden veranda
- 23 Library
- 24 Lower Courtyard
- 25 Laundry room
- 26 Gym
- 27 Meditation room
